**APPENDIX G:**

**Tubbs and Ladd Brook Project Development Summaries  
Pownal and Bennington, Vermont**

## River Corridor Plan for Tubbs and Ladd Brook - Project Development

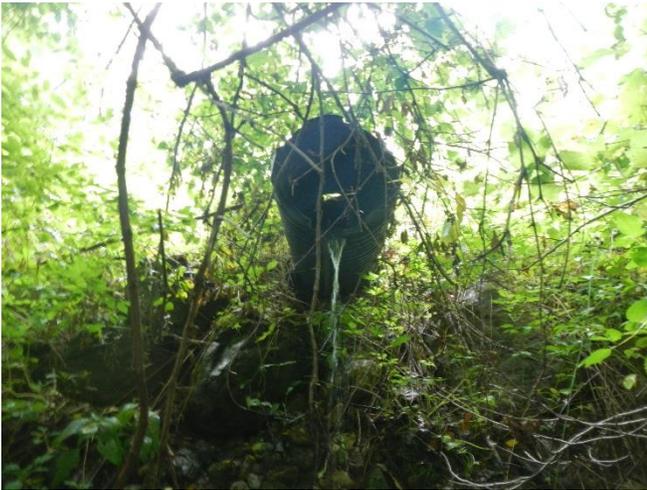
Project TB 6 is found at the intersection of Skiparee Road and Hemlock Hill Road in Pownal. Two culverts carry an intermittent tributary to Tubbs Brook, crossing first beneath Hemlock Hill Road through a 24-inch corrugated steel culvert, and then beneath Skiparee Road through an 18-inch corrugated plastic culvert (see Figure 6 on page 5). The outlet end of the 18-inch culvert is perched approximately 5 feet above a steep riprap slope (Figure 1), which then descends another 10-12 feet down a very steep embankment (approx. 1V:1H) into a gully. The gully flows to the west and into Tubbs Brook (Reach M01T1.02). It appears the gully has incised significantly through an erodible terrace feature along the brook over the years, as the outlet to the Tubbs Brook channel is V-shaped and 4-5 feet deep.

**Figure 1:** Perched culvert causing erosion and gully along the embankment of Skiparee Road.

We evaluated the culverts beneath both roads for hydraulic capacity, and found that both culverts are undersized for the upstream watershed area of 35 acres. Culvert were analyzed with FHWA HY-8 software, and watershed hydrology was estimated using a rainfall-runoff model of the upstream area using NRCS TR-20 methods (i.e., HydroCAD). Based on this analysis, we estimated that a 36-inch diameter culvert would be required to accommodate the 25-year storm without overtopping the road. This is consistent with VTANR’s culvert sizing recommendations for intermittent streams based on the upslope drainage area.

The existing 18-inch HDPE culvert will be replaced with a 36-inch HDPE culvert by the Town. We estimate the culvert will need to be at least 35 feet long to achieve the desired profile. Recommended design elements include:

- Maintain a similar inlet configuration, but drop the outlet elevation 4-5 feet to reduce the drop into the gully and thereby reduce future scour (see Figure 7 on page 6).
- Install appropriate gravel bedding beneath the new culvert, and use geotextile fabric as needed to separate native soils from bedding if saturated heavy soils are encountered.
- Install Type II stone riprap at the culvert outlet and continue 10-15 feet downstream to slope break. Avoid use of geotextile fabric to separate Type II stone from native soils (use gravel bedding as needed).
- Stabilize the upper banks between the Type II stone and the road edge with topsoil, erosion control fabric (or mulch hay on flatter slopes), and conservation seed.

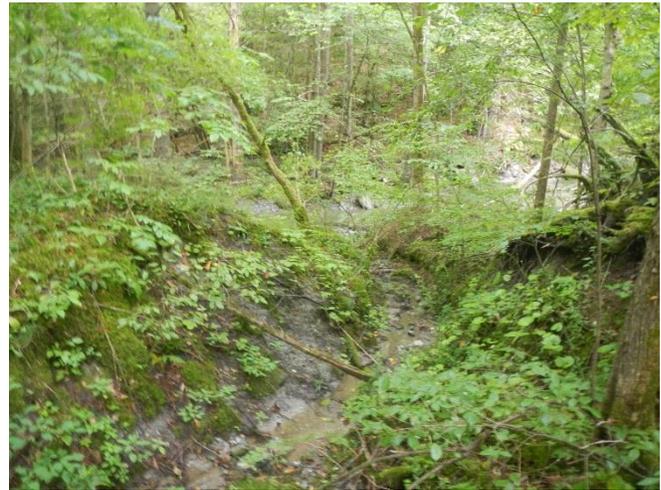
**Figure 2:** Gully downstream of the unstable culvert outlet. Tubbs Brook is in the background.

This reach of Tubbs Brook shows signs of significant aggradation (i.e., accumulation) of gravel in the main channel, which has led to widening and bank erosion downstream. The gully has likely been a large source of sediment to the brook over the years, and continues to be a significant source today as the banks are unstable and the undersized culvert likely “jets” water at the banks during large runoff events. The soils at the site are a Georgia Loam, which are prone to erosion (i.e., classified as highly erodible), particularly in the river corridor where finer sediment deposits are found. We estimate that over 50 cubic yards of soil has eroded into Tubbs Brook from this location in the past, contributing to fine sediment loading and impaired status of the brook. This is equivalent to about 3 large dump trucks of sediment.

Based on our survey data and gully observations, and past experience with similar gully stabilization projects, we think a non-mechanized approach to gully stabilizing would be best. Machinery access is very challenging given the steep terrain, and would involve clearing trees on steep slopes close to the brook. Therefore, we recommend the work be completed with hand labor. The following design elements are recommended:

- Utilize a work crew such as Vermont Youth Conservation Corps (VYCC) or similar group for up to 2 days to install up to three (3) log check dams (see Figure 7 on page 6).
- Check dams will be made of a combination of decay-resistant logs and stone, along with rebar and timberlock screws for stabilizing and fastening the structures (see specifications on following page).

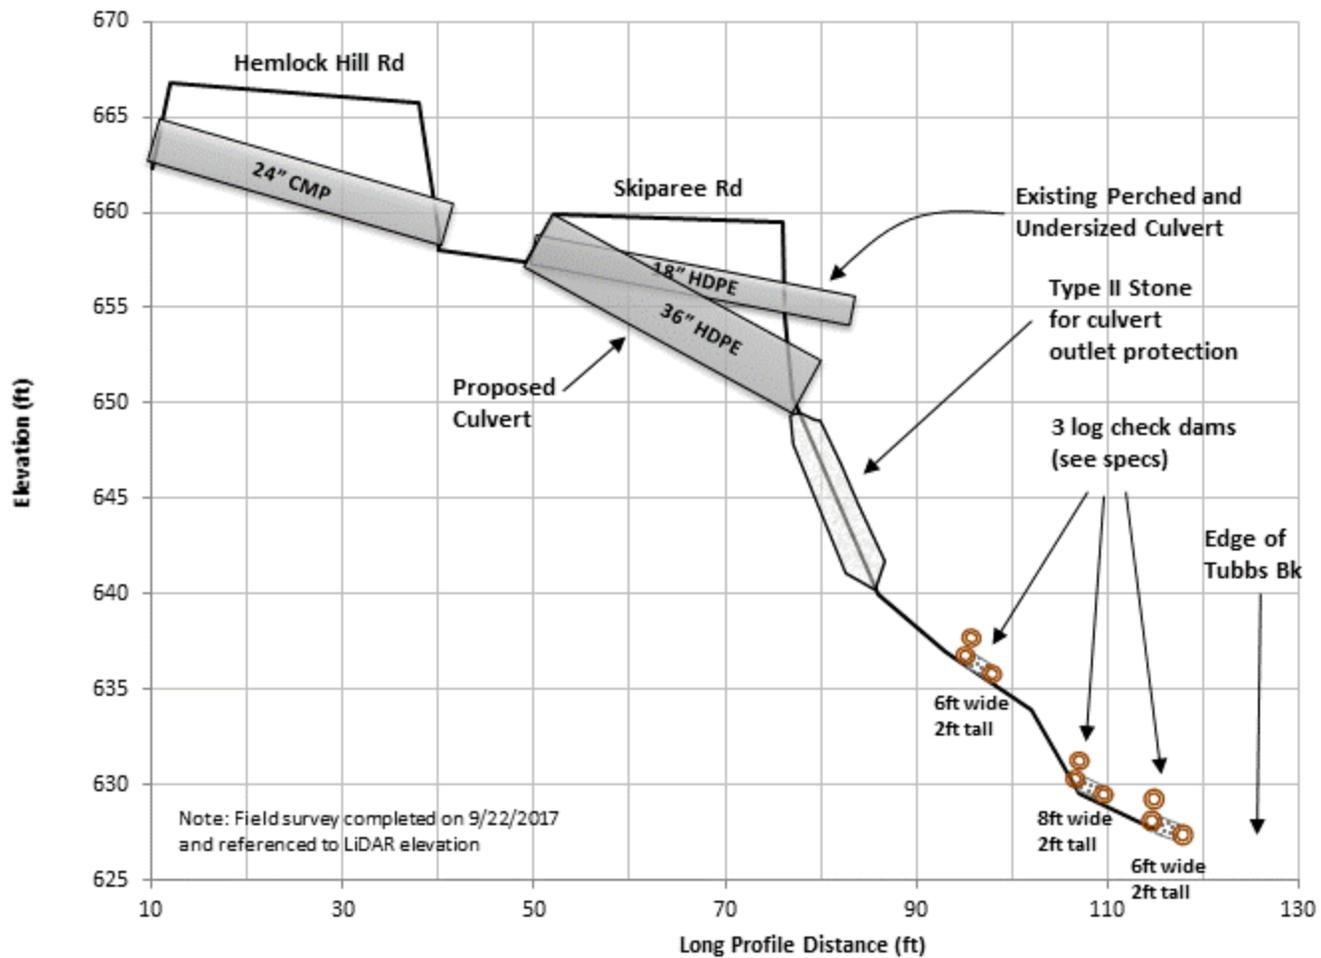
Figure 7: Longitudinal profile of Hemlock Hill and Skiparee Road culverts and downstream gully to Tubbs Brook.

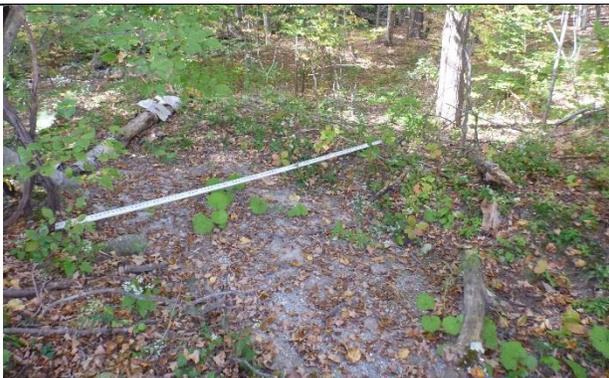
**Existing Conditions Notes:** Approximately 500 feet of Fowlers Way has no ditch on the eastern side of the road and 350 feet of the western side of the road lacks effective turnouts, causing runoff to flow along the road and erode the roadway. The side slopes on the lower 200 feet of Fowler Road limit sheet flow off the road, exacerbating downslope erosion. Runoff along the road causes rill erosion and contributes to sediment loading at the turnout downslope of the intersection with Mt. Anthony Road. This turnout is conveying sediment into Tubbs Brook. Approximately 175 feet of Mount Anthony Road is lacking a ditch on the north side of the road, further contributing to sediment loading at the turnout from runoff flowing on the road surface. This reach of Tubbs Brook shows signs of significant aggradation (i.e., accumulation) of gravel in the main channel, which has led to widening and bank erosion downstream. This turnout is a significant source of sediment to the brook.

**Photo 1:** A turnout near Tubbs Brook at the intersection of Fowlers Way and Mt. Anthony road is filling with sediment.

<b>X</b>	Install Turnout	<b>X</b>	Stabilize/Improve Existing Turnout
<b>X</b>	Install Sediment Trap		Stone Armor on Bank/Slope
<b>X</b>	Install Check Dams in Existing Feature

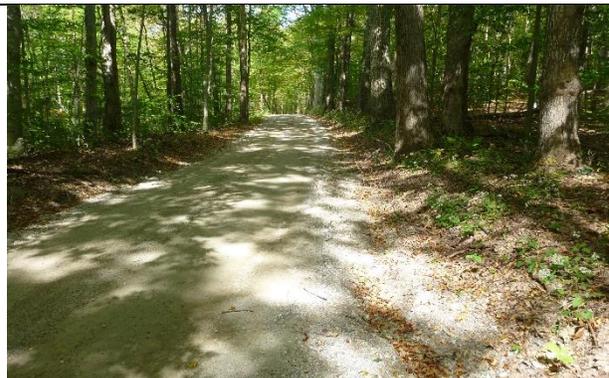
**Photo 2:** Rill erosion along the section of Fowlers Way with no ditches.

<b>X</b>	Install New Ditch	<b>X</b>	Improve Existing Ditch
<b>X</b>	Side Slope Excavation for New Ditch

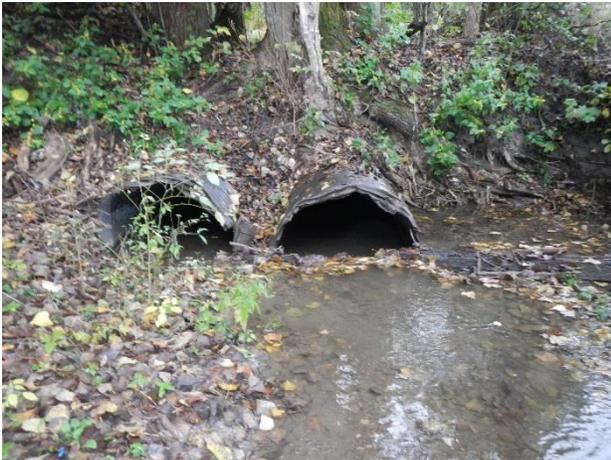
Two culverts (4ft diameter) convey the stream under an old, unused crossing west (downstream) of the railroad crossing (Figures 10 and 11). These structures are causing sediment and debris deposition at the inlet, and aggradation in the upstream channel. The culvert capacity is exceeded during flood events, backing up floodwaters and increasing flood depths upstream.

**Figure 10:** Undersized culvert inlets at an abandoned crossing.

To increase the capacity of Ladd Brook to pass large floodflows, reduce sedimentation in the channel, and reduce the risk of debris snagging at the inlet, we recommend either: 1) removing the crossing including the two culverts and fill above them, or 2) replacing the undersized structures with a culvert or bridge with a bankfull-sized opening. The channel in this stretch can be widened in the direction of the Green Mountain Racetrack property with the addition of a flood bench to increase the capacity of the channel. The newly excavated slopes and bench would be planted with native woody vegetation appropriate for the setting (bare root or small container trees, or willow stakes/fascines depending on shading).

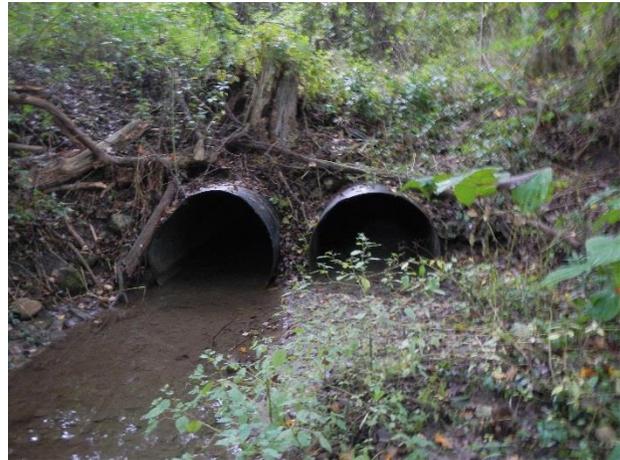
**Figure 11:** Undersized culvert outlets at an abandoned crossing.

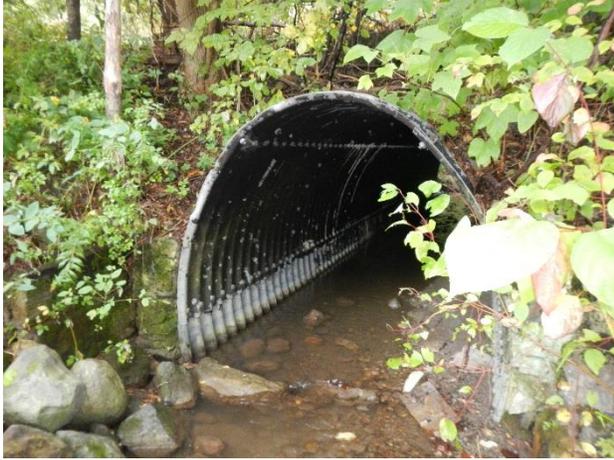
A railroad culvert (6ft tall and 4ft wide) is undersized (Figures 12 and 13). The bankfull channel width for this reach is 17 feet, therefore the culvert width is 24% of the reference width. The culvert capacity is exceeded during flood events, backing up floodwaters and increasing flood depths upstream. A stormwater channel with low slope and an elevation at or slightly below that of Ladd Brook runs alongside the mobile home park converges with Ladd Brook just upstream of the culvert. Thus, when floodwaters back up at the crossing they likely flow into the stormwater channel and may spill out into the mobile home park.

**Figure 12:** Undersized railroad culvert inlet.

In order to increase hydraulic capacity to pass large floodflows, reduce sedimentation in the channel, and reduce the risk of debris snagging at the inlet,, we recommend installing a larger structure to convey Ladd Brook underneath the railroad. The estimated bankfull width for this section of Ladd Brook is 17 feet. The existing structure causes the backup of floodwaters during the 10 and 25-year floods, raising flood depths upstream along the Alta Gardens mobile home park. The culvert and railroad are projected to overtop during the 50 and 100-year floods. Increasing the size of the railroad crossing to a bankfull structure is predicted to allow the crossing to pass all floods without backing up floodwaters and exacerbating flooding in Alta Gardens. The comparison of the existing and proposed structure width and water surface elevations from HEC-RAS modeling are shown in Figure 20. The costs associated with a crossing of this size are often in the \$200,000 to 300,00 range for municipal projects. However, given the potential disruption of the railroad and other uncertainties with this project, it is possible the costs could exceed \$500,000.

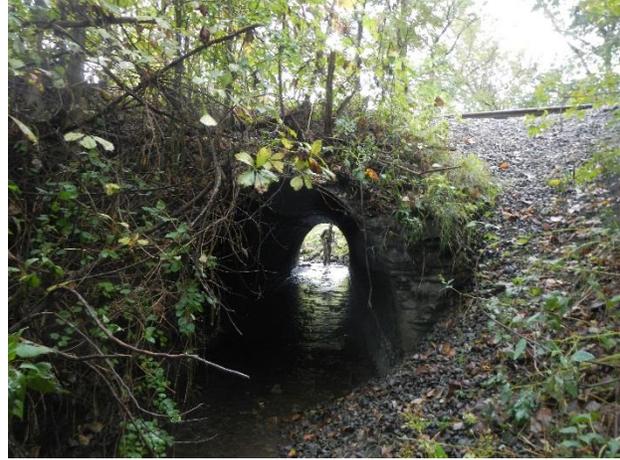
**Figure 13:** Undersized railroad culvert outlet.

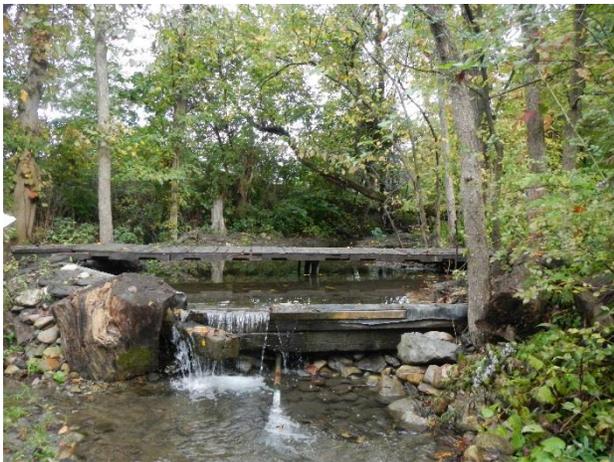
A makeshift dam constructed from railroad ties, stumps, and a rubber liner is found just upstream of the mobile home park (Figures 14 – 15). The structure is causing sediment aggradation upstream and raises the water level just upstream of the mobile home park. This may exacerbate flooding in the park.

**Figure 14:** Makeshift dam on Ladd Brook upstream of Alta Gardens.

The small size of the dam suggests it can be removed by hand. We estimate it would take two (2) laborers and a truck one (1) day to remove the structure and haul away the wood and liners so they do not clog either of the culvert crossings downstream. At the time of the field survey, the channel upstream of the dam appeared to have been recently dredged, resulting in a limited amount of sediment accumulation behind the dam. Due to the similar slope of the channel upstream and downstream of the dam as shown in Figure 21, likely no regrading of the channel is needed and what sediment is accumulated immediately behind the dam can be allowed to fill the scour hole downstream of the dam and depression left after the dam removal. Estimated total cost: \$1,000 - \$2,000.

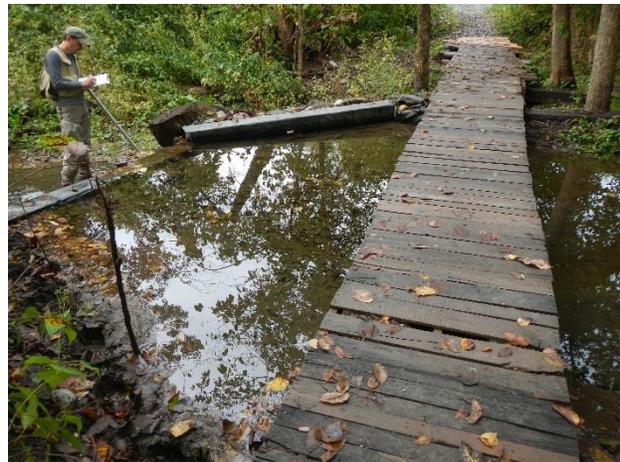
**Figure 15:** Sediment accumulates behind the makeshift dam.

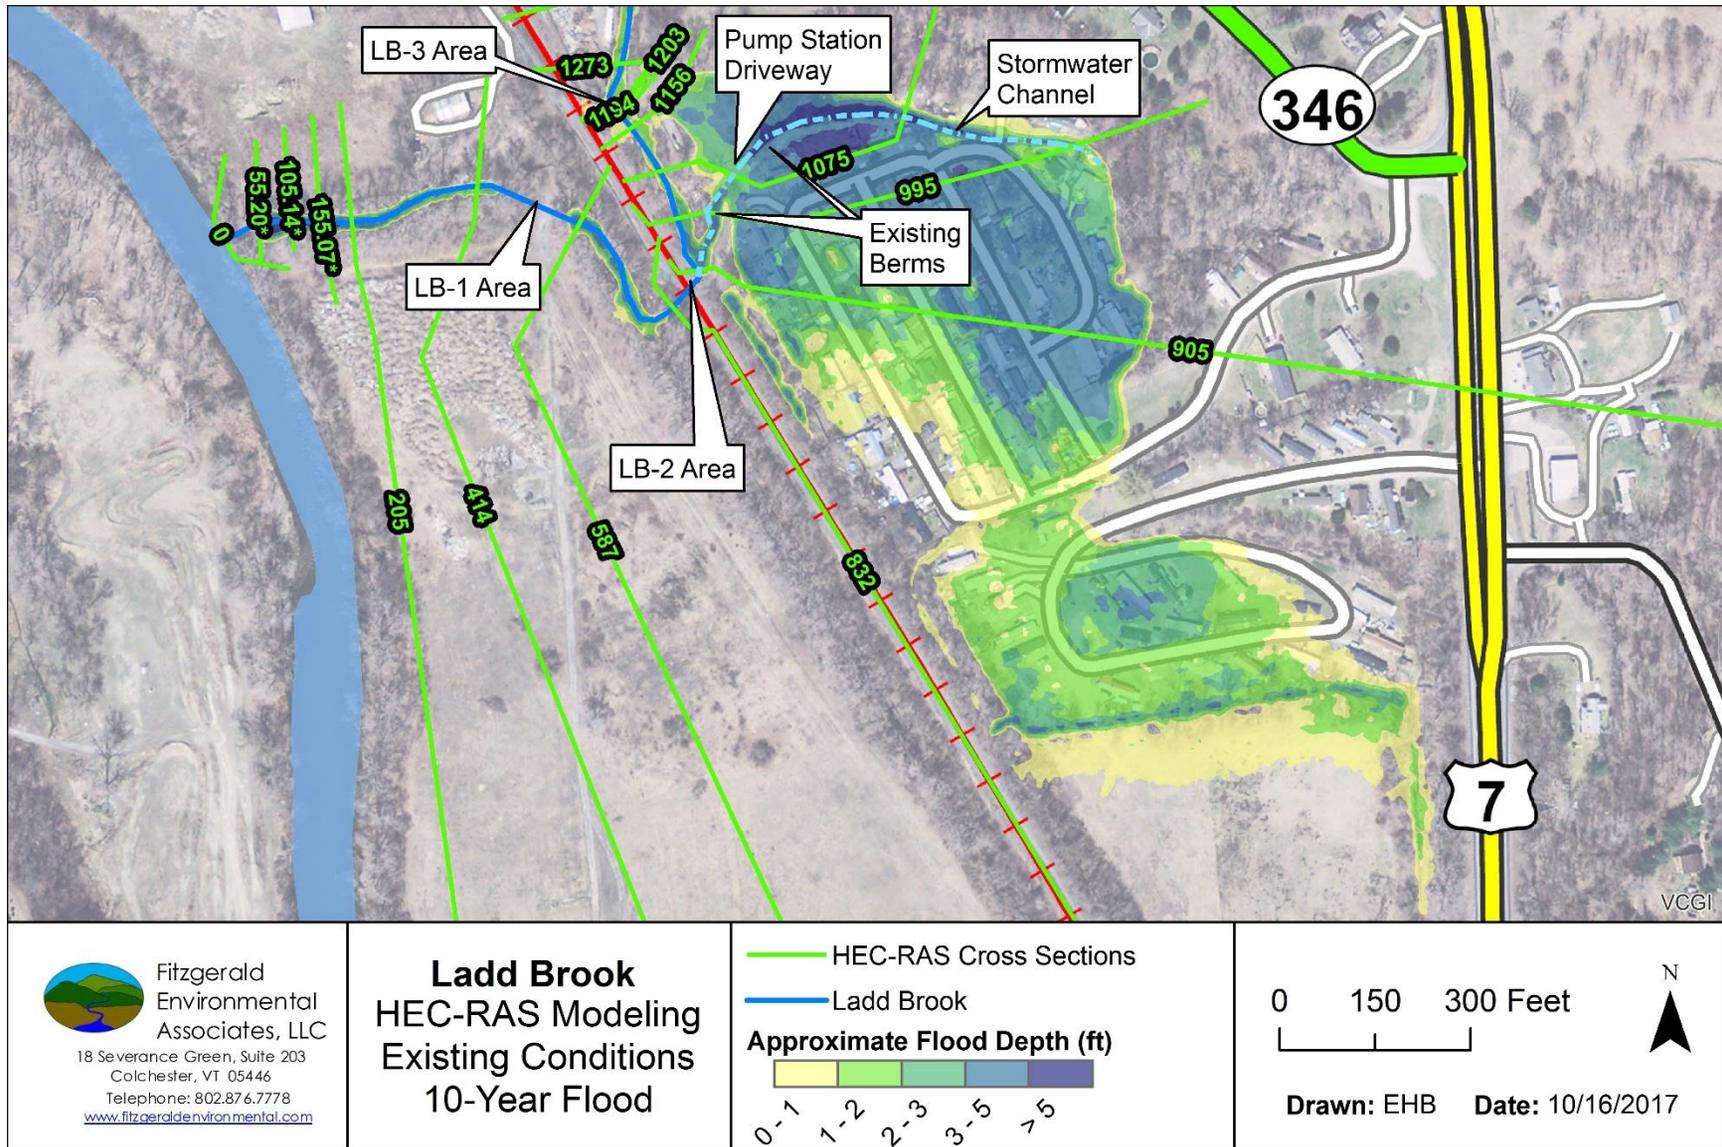
**Figure 16:** Ladd Brook approximate 10-year flood depths under existing conditions modeled with HEC-RAS.

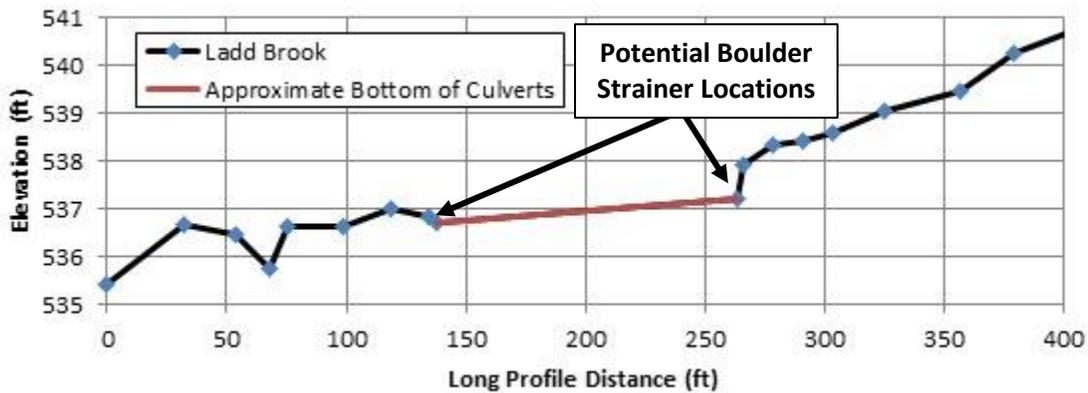
There is a steep drop-off of approximately one foot in channel elevation at the current inlet to one of the culverts at the crossing, so a low-profile grade control (i.e., boulder strainer) on the newly restored channel upstream and downstream of the former location may help prevent sediment losses and further incision of the channel (Figure 18). This project area can be accessed via the existing road from the Green Mountain Racetrack property. Final design and permitting work will be needed for this project. Our estimated cost to remove the crossing and restore the stream channel: \$25,000 - \$30,000.

**Figure 18.** Long profile of Ladd Brook channel upstream and downstream of the double culverts.

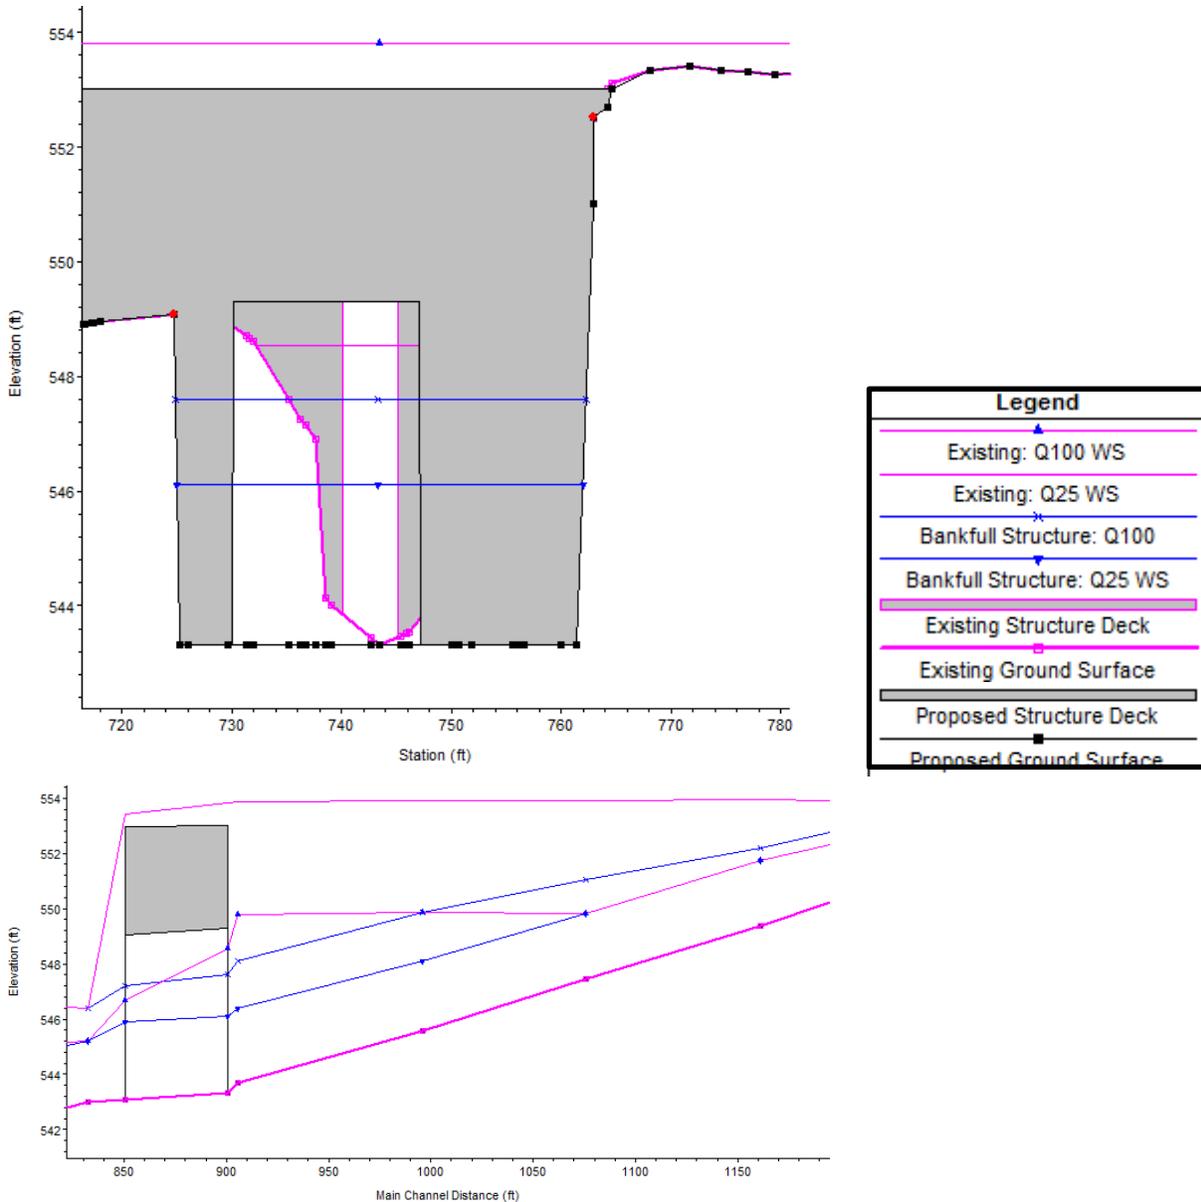
**Figure 20.** Cross section (top) and longitudinal profile (bottom) views of the Water Surface (WS) elevations in scenarios with the existing railroad culvert and a new bankfull structure. Pink lines show the existing ground and water surface as well as outline existing structure openings, black lines show the proposed ground surface as well as proposed structure openings and blue lines show the modeled water surface if the project were implemented. Q25 is the modeled 25-year flow event scenario and Q100 is the modeled 100-year flow event scenario. Gray shading shows the deck/abutments of existing and proposed structures.
