Traffic Calming Study

Old Bennington, Vermont

Bennington County Regional Commission

DRAFT 8-4-2014

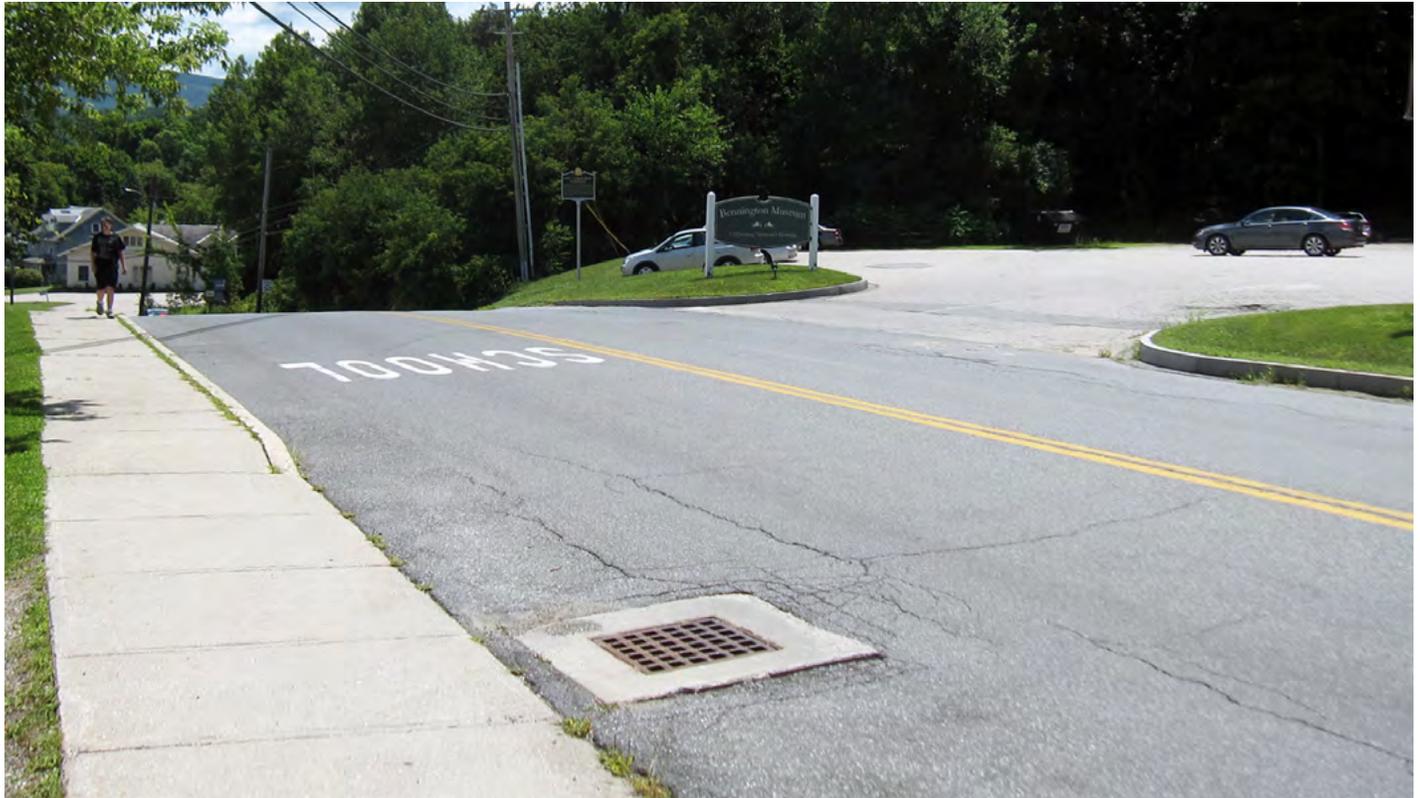
There is no crosswalk to reach the Bennington Museum, and no buffer between the sidewalk and the travel lane, which mars the streetscape and makes walking unpleasant.

- Install permanent speed feedback signs for each travel direction.
- Install a crosswalk and neck-down so pedestrians can safely cross Main Street to reach the Bennington Museum. The crosswalk should be where there is adequate site distance, away from the steepest part of the hill.
- Increase speed and impaired driving enforcement.

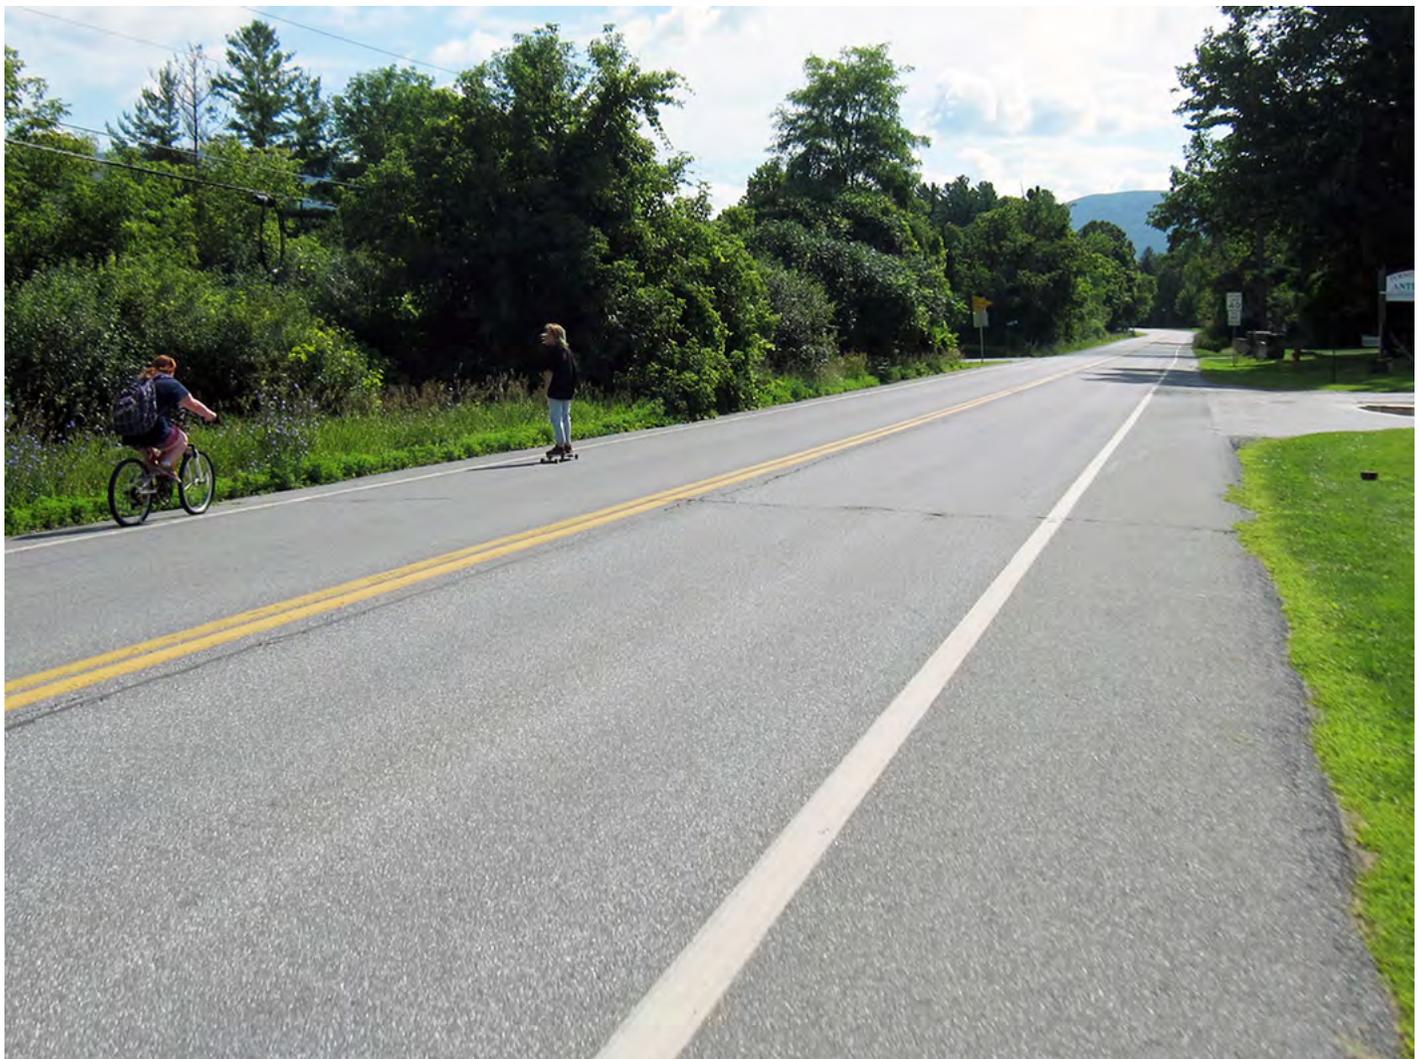
A straightaway on West Road near the Village encourages speeding. A curve obscures the village ahead.

- Install a center island narrowing with plantings and a village welcome sign just east of the Village boundary. Locate the center island so it does not hinder access to driveways on the south side of the road.
- Request VTrans:
 - Extend the 40 mph zone west to Quarry Road.
 - Narrow the travel lanes in the 40 mph zone from 12-feet to 11-feet.

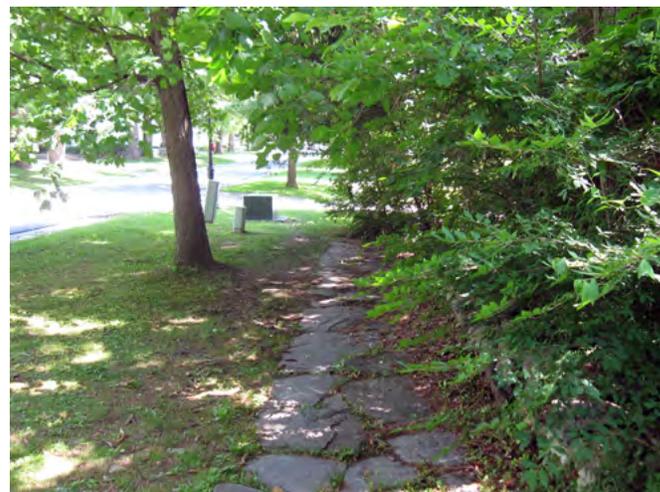
Branches block this section of dilapidated sidewalk on Upper Monument Ave.

Reconstruct damaged sidewalks and install ADA compliant curb ramps.

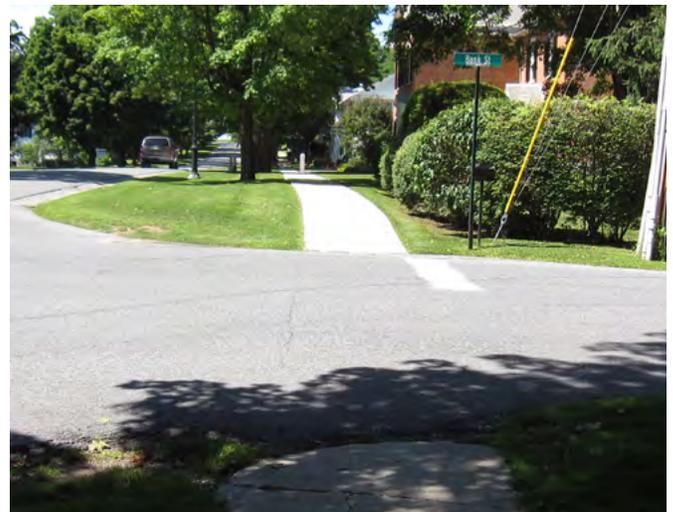
There is no crosswalk to safely cross Bank Street.

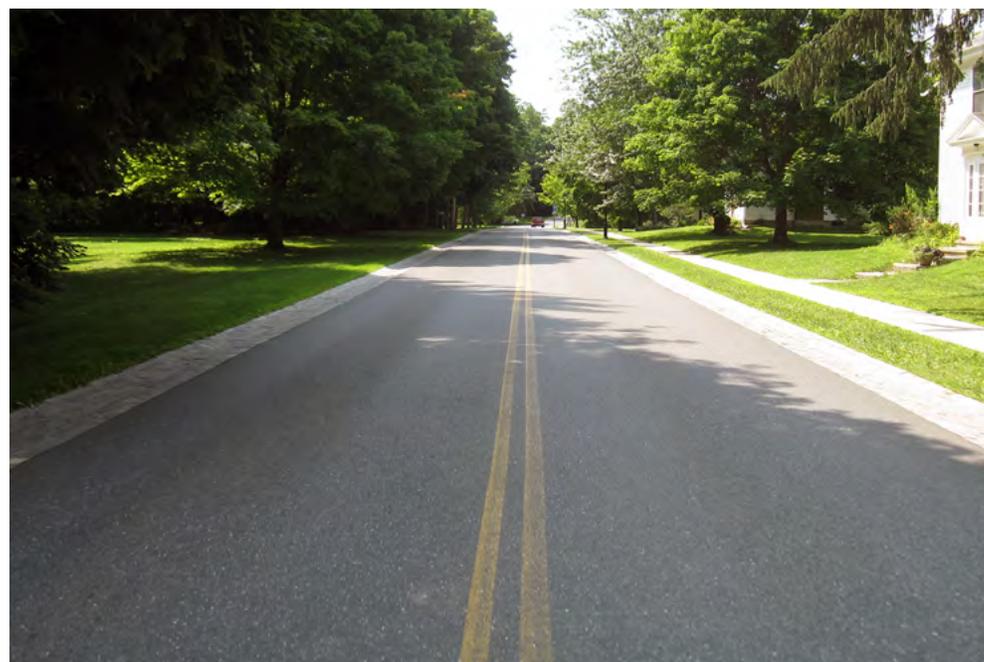
Lower Monument’s straight alignment invites speeding. The yellow centerline, which is not warranted by the MUTCD, makes the street look more like a highway.

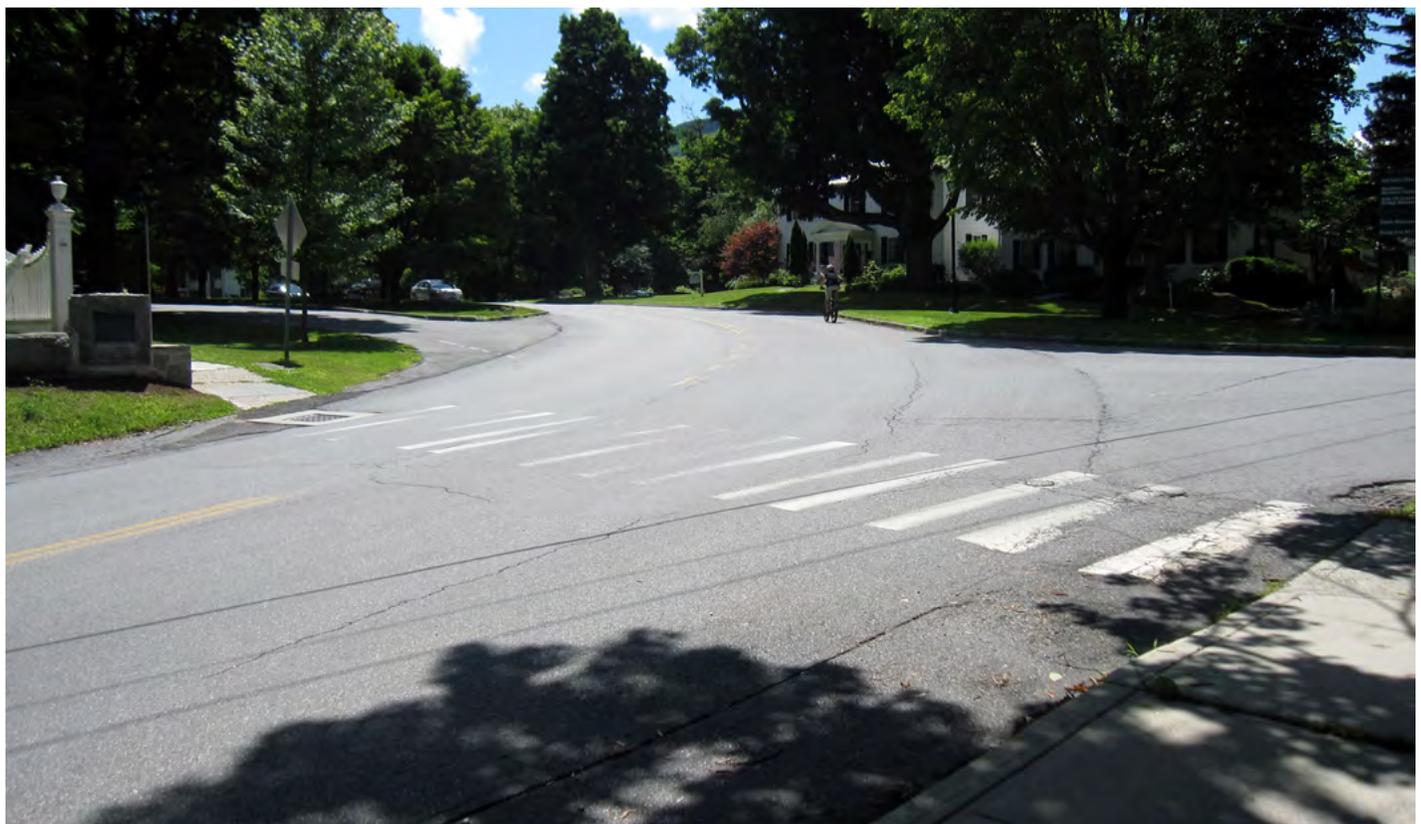
The crosswalk at Main Street /VT-9 has a long crossing distance due to a long corner radius. The drain inlet in the middle of the crosswalk is a trip hazard.

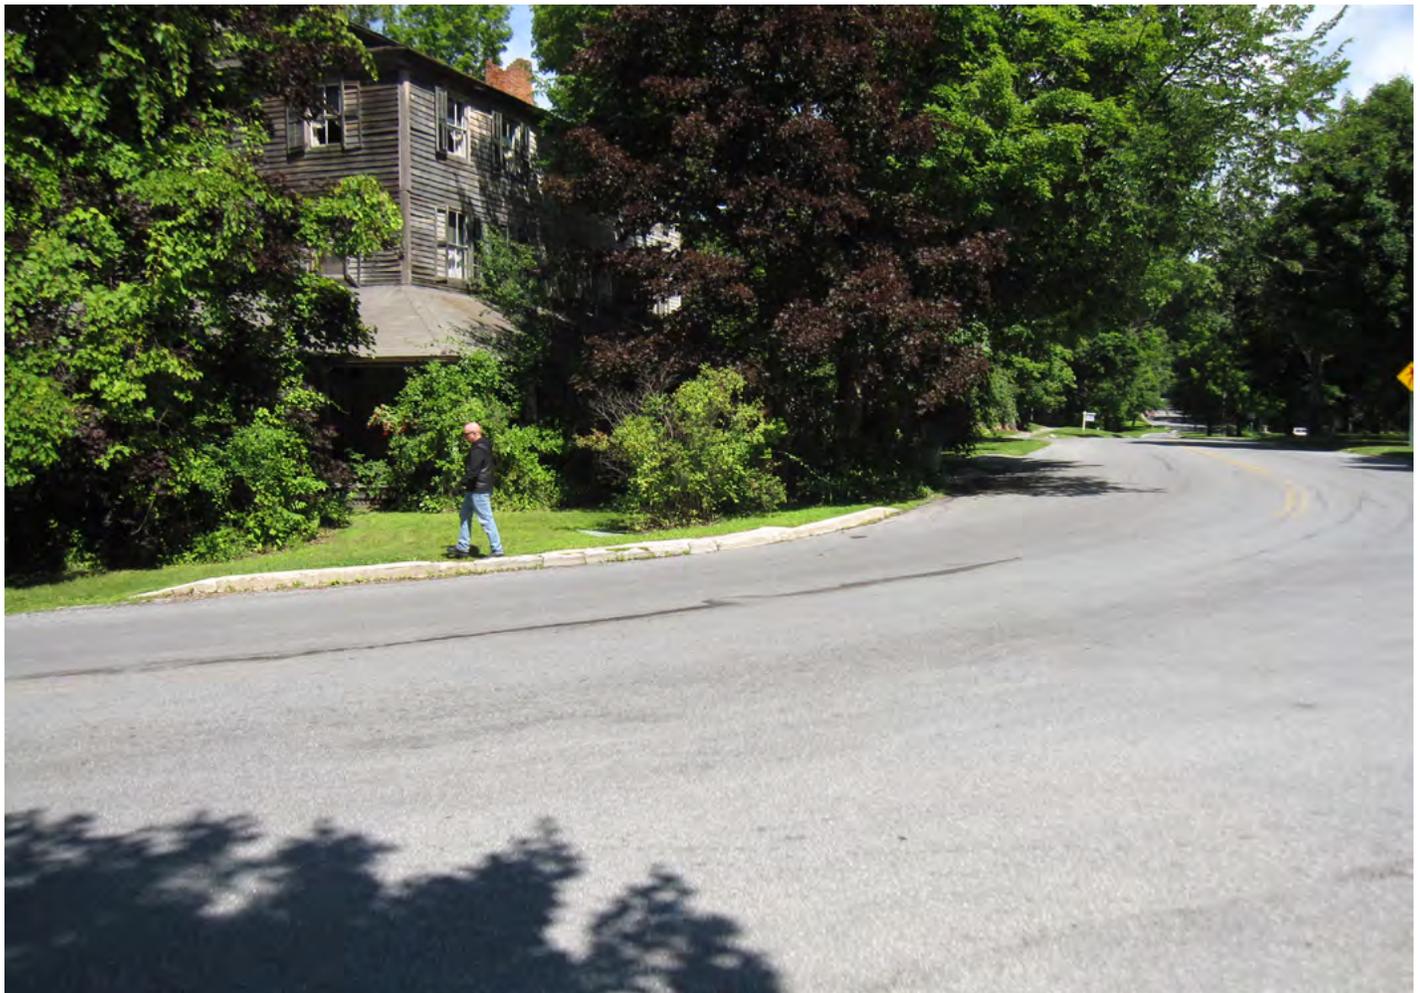
VT-9 is wider than necessary near the village green which limits pedestrian space and encourages aggressive driving.

- Lack of bicycle lanes or markings on VT-9
- *Solutions:* (short-term) Install 5-foot bike lanes on VT-9

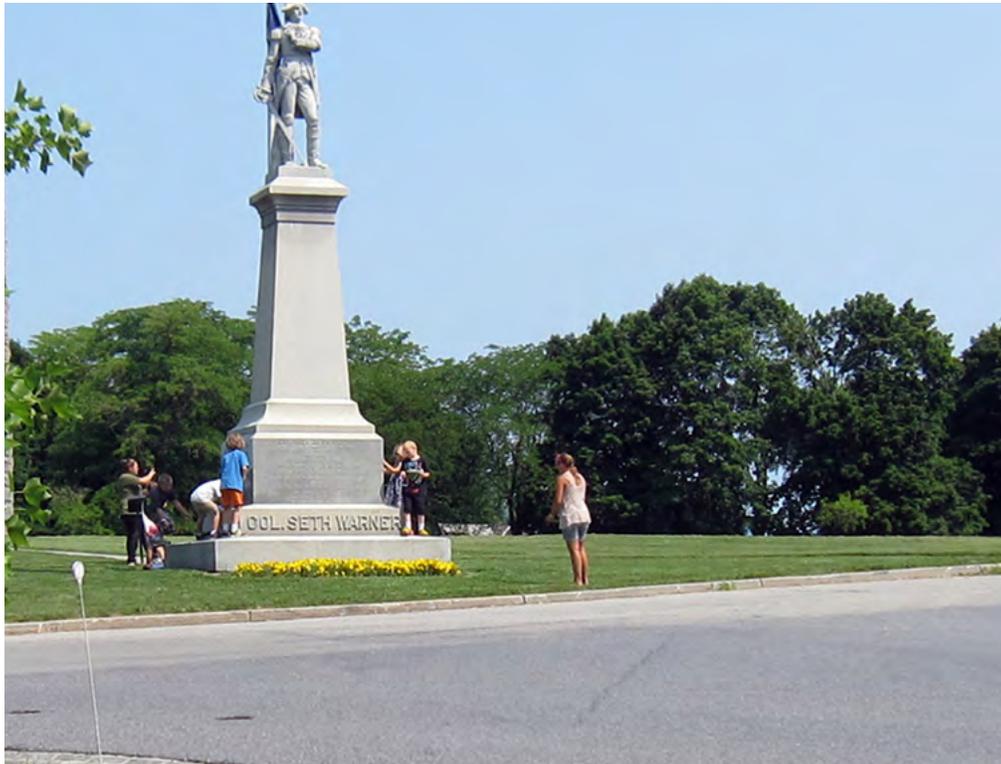
Park visitors could use more space in front of the Seth Warner statue.

- Study the feasibility of constructing a planted pedestrian refuge island near the top of Monument Avenue to calm traffic and to give visitors a place to photograph the monument.

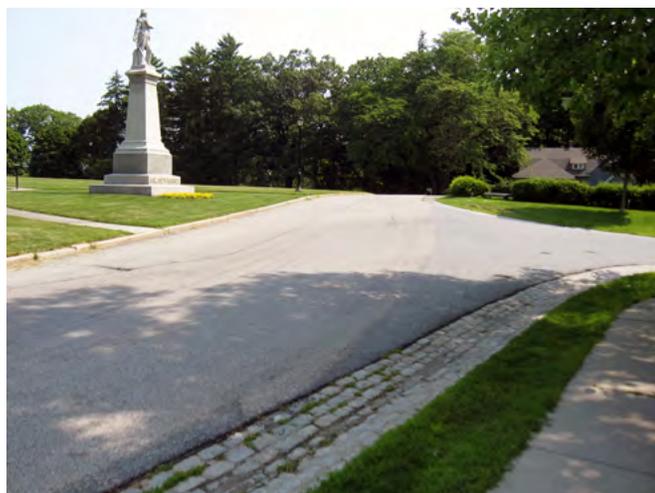
A wide corner radius encourages fast right turns onto Monument Ave.

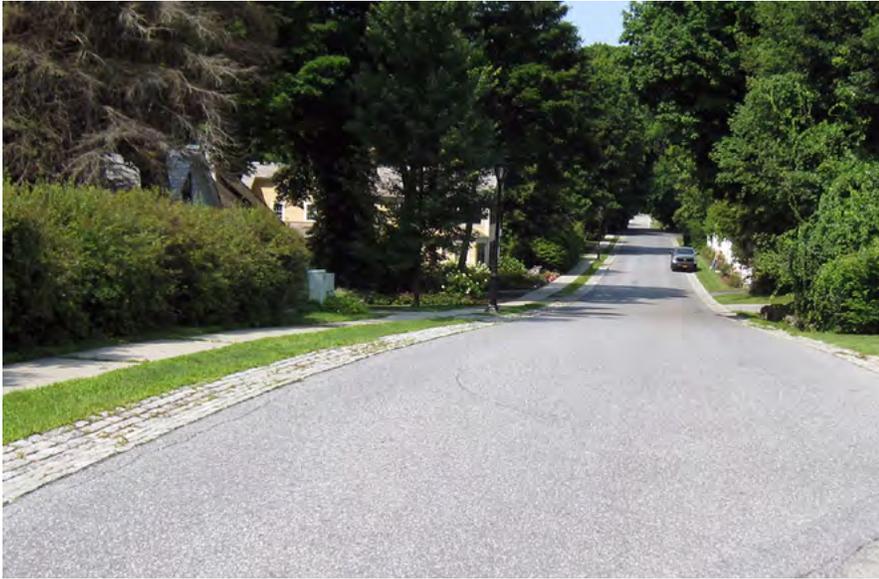
A straightaway encourages speeding on Walloomsac Rd.

- Replace the four-way stop with a mini-roundabout at the Walloomsac/Fairview intersection.
- Install a chicane on Fairview with a design speed of 20-25 mph to interrupt the straightaway south of the Bennington School.
- Install a speed table on Walloomsac Rd. with a design speed of 20-25 mph.
