**APPENDIX G:**

**Tubbs and Ladd Brook Project Development Summaries  
Pownal and Bennington, Vermont**

## River Corridor Plan for Tubbs and Ladd Brook - Project Development

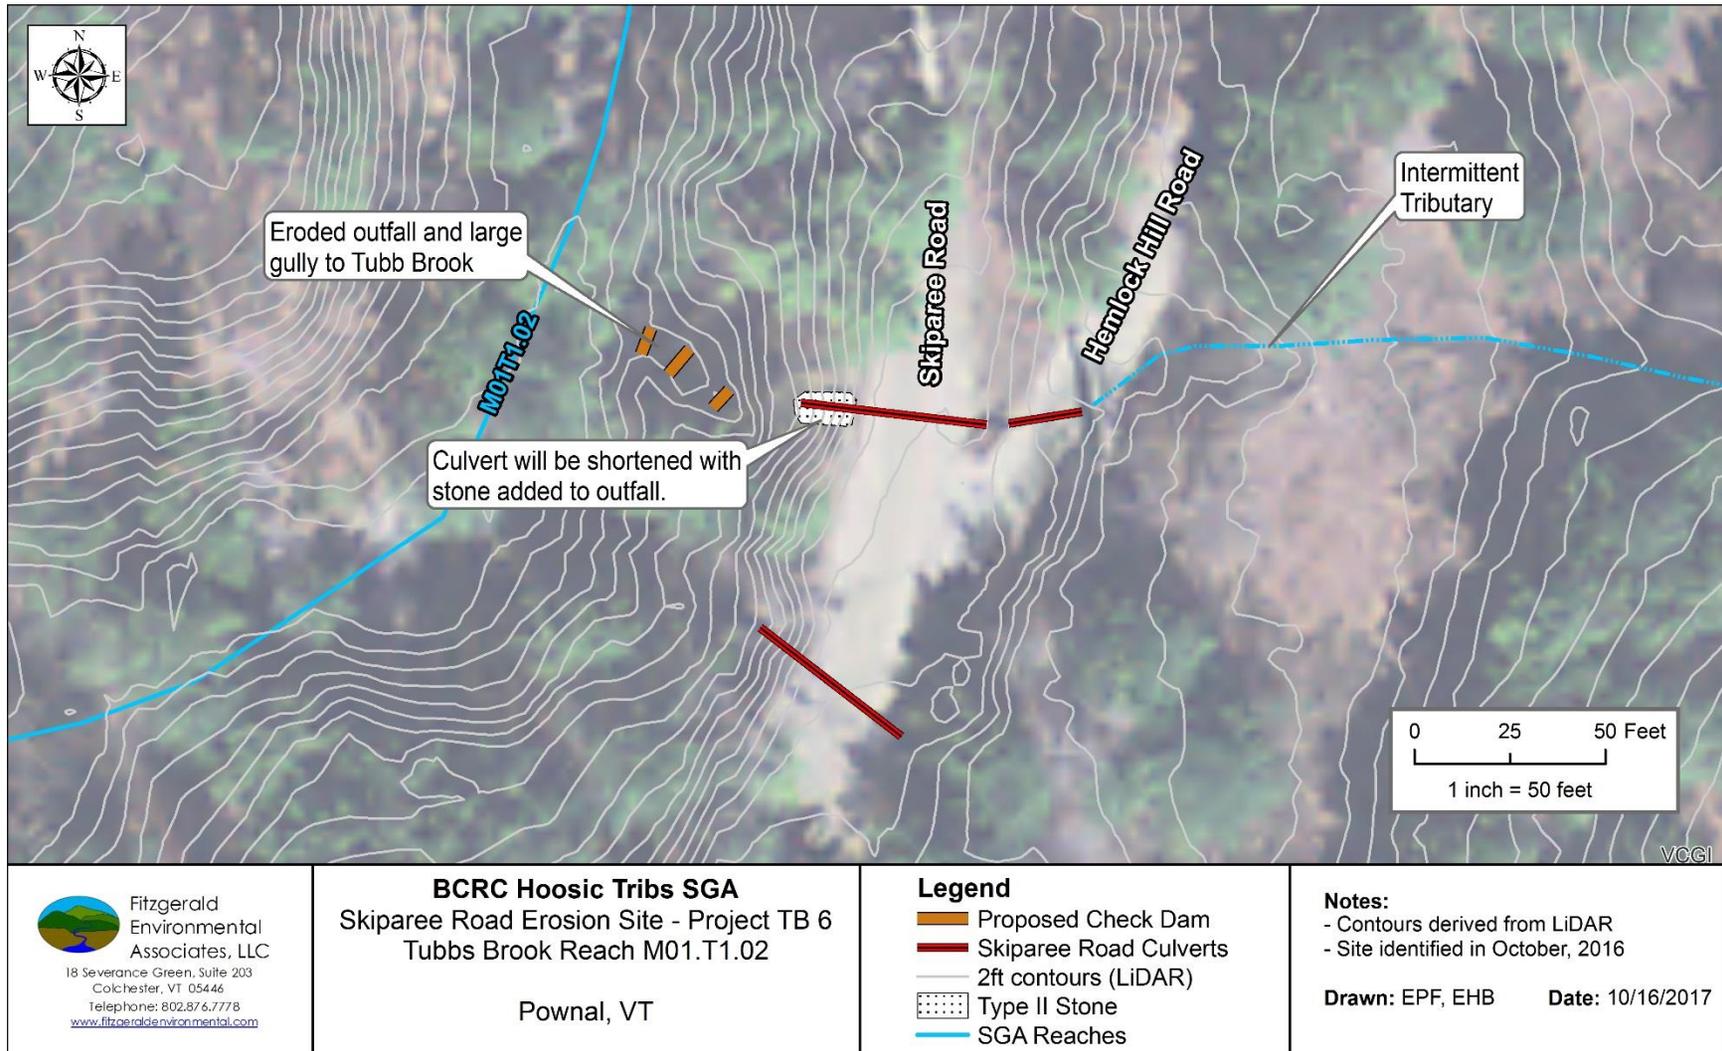
Project TB 6 is found at the intersection of Skiparee Road and Hemlock Hill Road in Pownal. Two culverts carry an intermittent tributary to Tubbs Brook, crossing first beneath Hemlock Hill Road through a 24-inch corrugated steel culvert, and then beneath Skiparee Road through an 18-inch corrugated plastic culvert (see Figure 6 on page 5). The outlet end of the 18-inch culvert is perched approximately 5 feet above a steep riprap slope (Figure 1), which then descends another 10-12 feet down a very steep embankment (approx. 1V:1H) into a gully. The gully flows to the west and into Tubbs Brook (Reach M01T1.02). It appears the gully has incised significantly through an erodible terrace feature along the brook over the years, as the outlet to the Tubbs Brook channel is V-shaped and 4-5 feet deep.

**Figure 6:** Site map of Hemlock Hill and Skiparee Road culverts and downstream gully to Tubbs Brook.

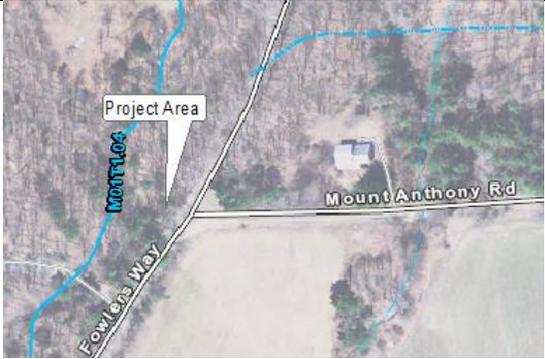
<p><b>Existing Conditions</b>                  LiDAR Slope: 10% (Fowlers); 3-10% (Mt. Anthony)                  Road Type: Gravel                  Conveyance Area/Turnout: 3 Poor, 1 Stable                  Erosion Types Present: Rill                  Drainage Culverts: 1 Cross                  Driveway Culverts: 0</p>

**Existing Conditions Notes:** Approximately 500 feet of Fowlers Way has no ditch on the eastern side of the road and 350 feet of the western side of the road lacks effective turnouts, causing runoff to flow along the road and erode the roadway. The side slopes on the lower 200 feet of Fowler Road limit sheet flow off the road, exacerbating downslope erosion. Runoff along the road causes rill erosion and contributes to sediment loading at the turnout downslope of the intersection with Mt. Anthony Road. This turnout is conveying sediment into Tubbs Brook. Approximately 175 feet of Mount Anthony Road is lacking a ditch on the north side of the road, further contributing to sediment loading at the turnout from runoff flowing on the road surface. This reach of Tubbs Brook shows signs of significant aggradation (i.e., accumulation) of gravel in the main channel, which has led to widening and bank erosion downstream. This turnout is a significant source of sediment to the brook.

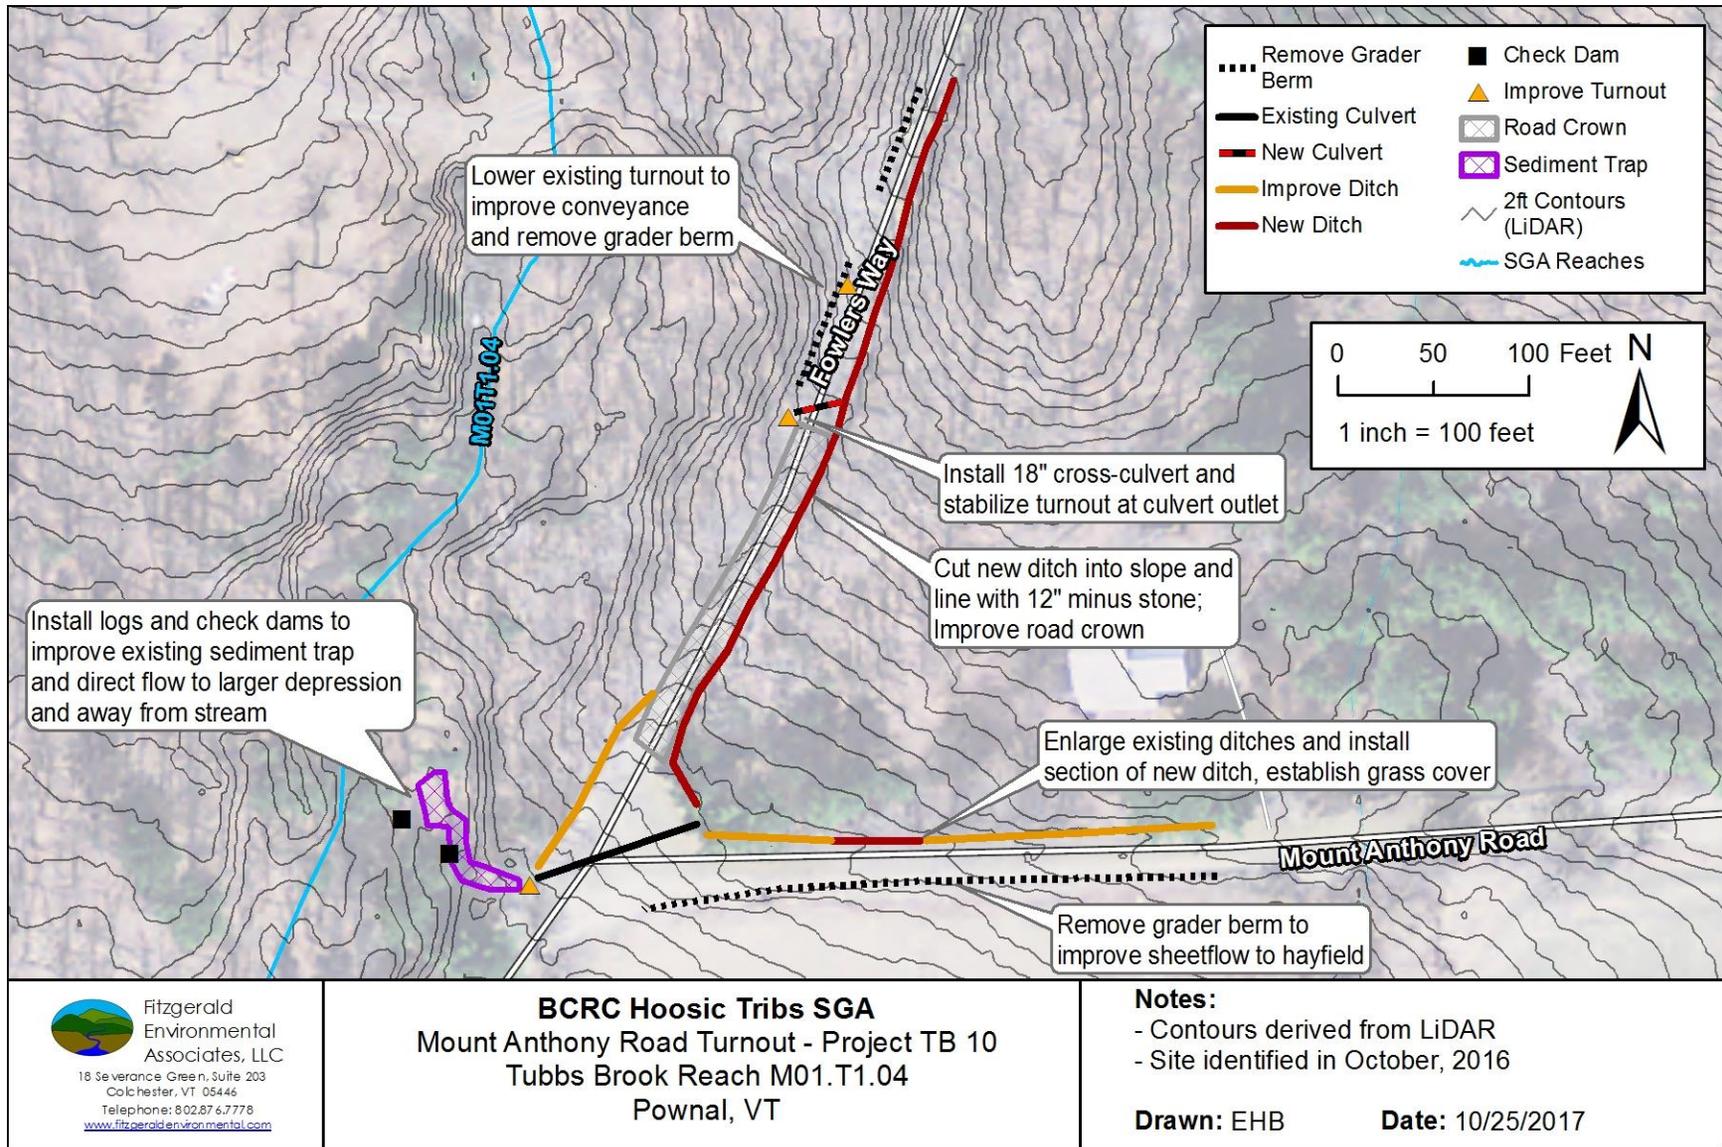
Figure 8. Proposed plan for the TB 10 project area.

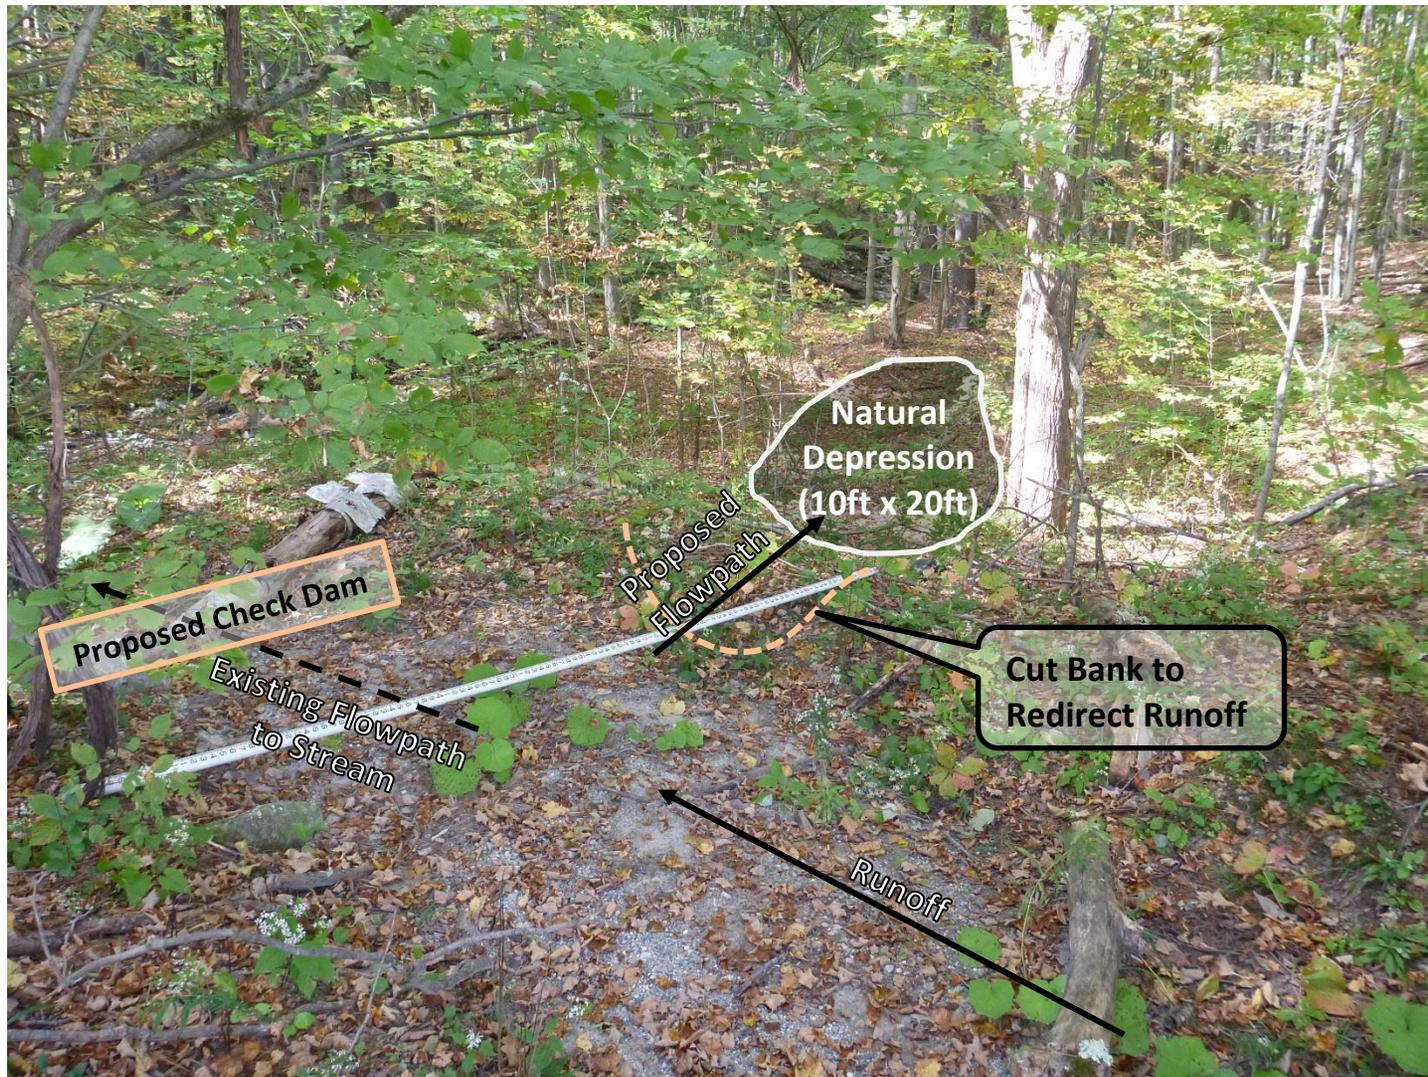
**Figure 9.** Proposed sediment trap retrofit in natural depression (10-foot stadia rod for scale).

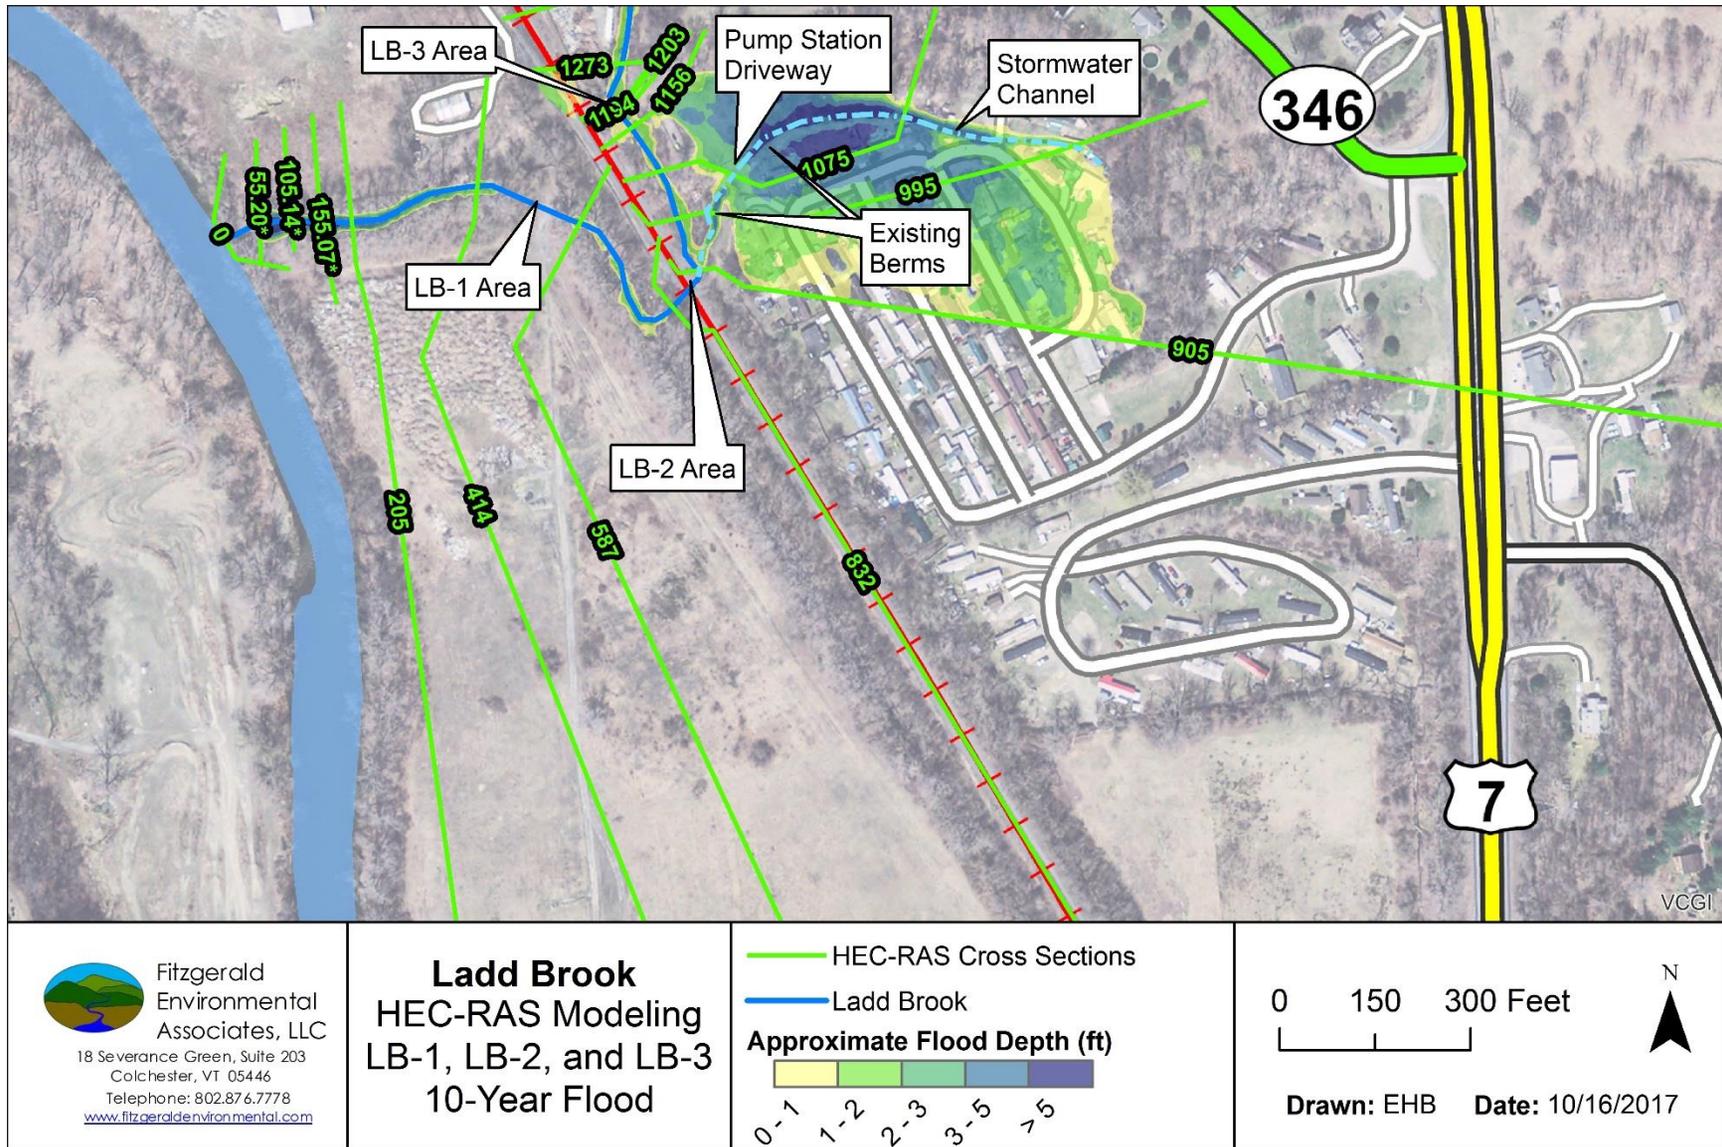
50 to 100-year	No benefit compared to existing conditions (Hoosic tailwater is higher than the elevation of the crossing)	No benefit compared to existing conditions from removal of lower stream crossing (LB-1)	No benefit compared to existing conditions from removal of lower stream crossing (LB-1)
LB-2: <i>Railroad Culvert Replacement with a 17-foot Wide Structure</i>	10 to 25-year	No benefit in downstream area compared to existing conditions	Flood elevations approximately 3 – 4 feet lower, reducing the depth and extent of flooding in Alta Gardens	Flood elevation approximately 0.5 – 1 foot lower
	50 to 100-year	No benefit in downstream area compared to existing conditions	Flood elevations approximately 6 feet lower, reducing the depth and extent of flooding in Alta Gardens	No significant benefit compared to existing conditions
LB-3: <i>Dam Removal</i>	10 to 25-year	No benefit in downstream area compared to existing conditions	No benefit near railroad culvert inlet compared to existing conditions	Flood elevations approximately 1 foot lower

**Figure 17:** Ladd Brook approximate 10-year flood depths after implementation of LB-1, LB-2 and LB-3 modeled with HEC-RAS.

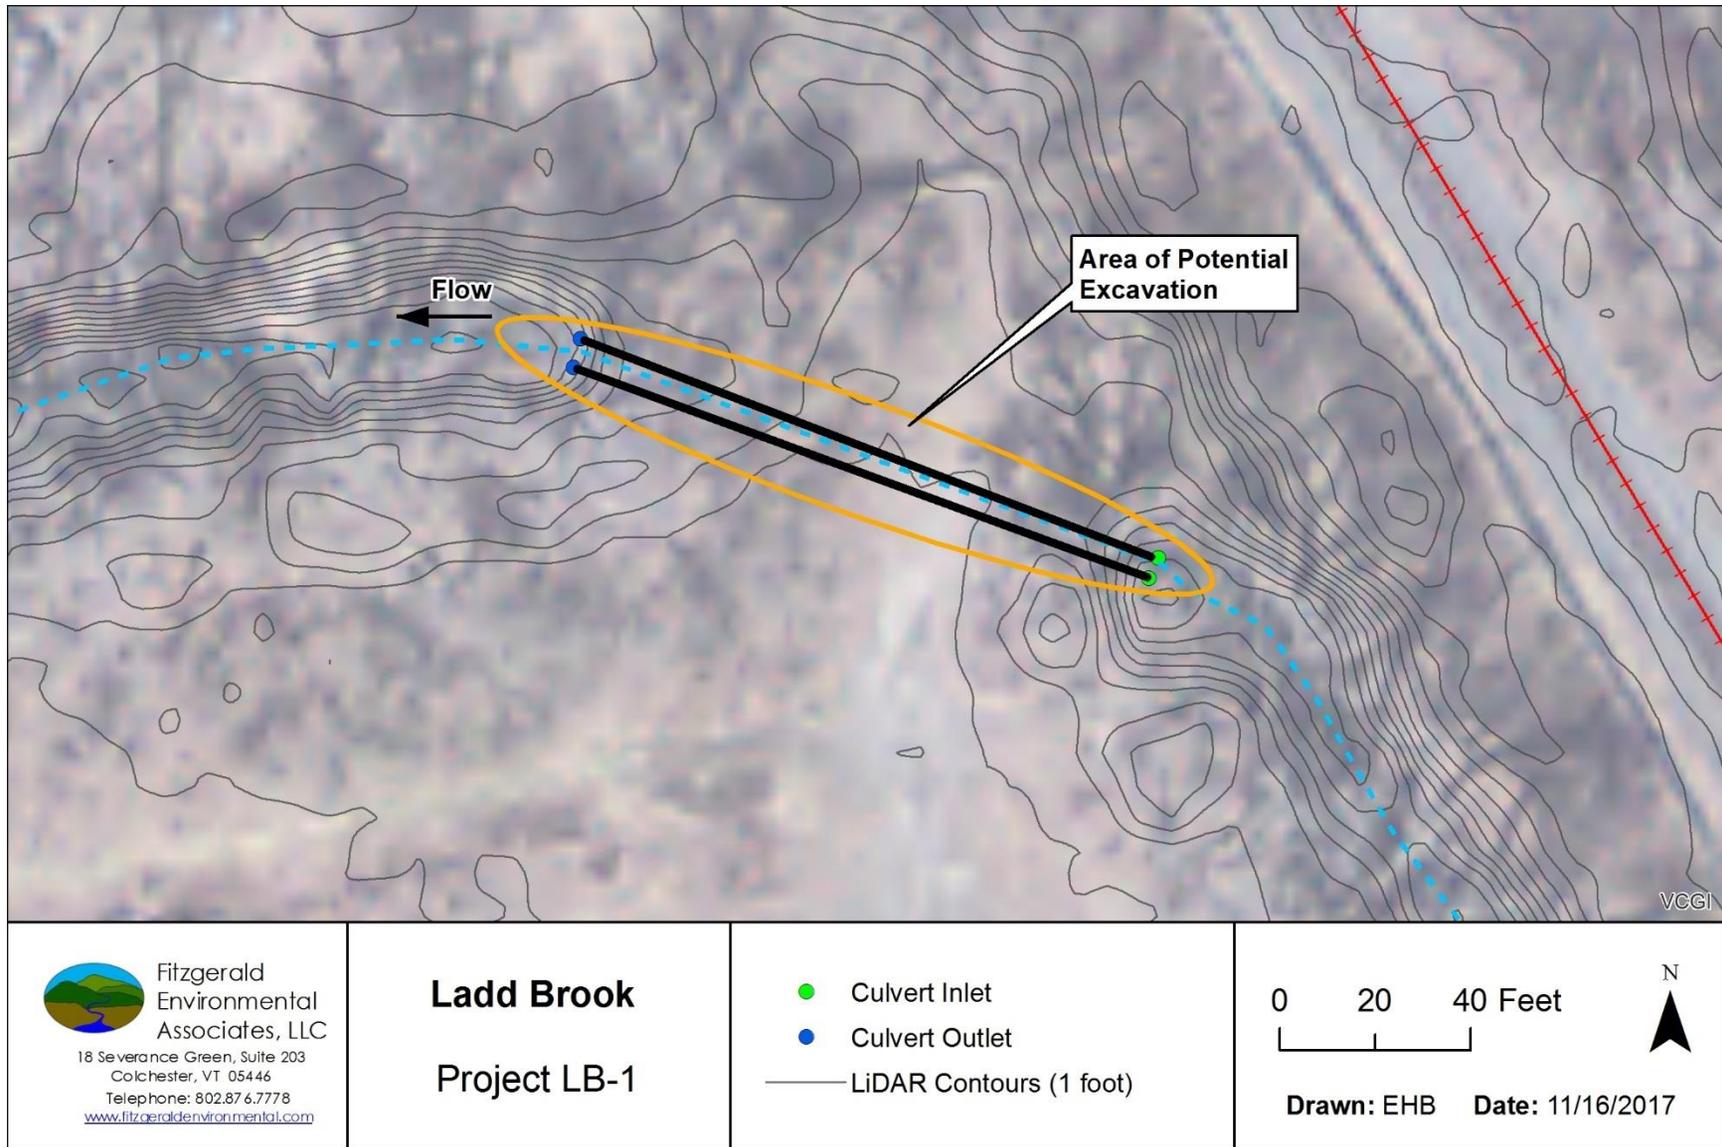
**Figure 19.** Location of double culverts and proposed area of excavation to remove the crossing.

To increase the capacity of Ladd Brook to pass large floodflows, reduce sedimentation in the channel, and reduce the risk of debris snagging at the inlet, we recommend either: 1) removing the crossing including the two culverts and fill above them, or 2) replacing the undersized structures with a culvert or bridge with a bankfull-sized opening. The channel in this stretch can be widened in the direction of the Green Mountain Racetrack property with the addition of a flood bench to increase the capacity of the channel. The newly excavated slopes and bench would be planted with native woody vegetation appropriate for the setting (bare root or small container trees, or willow stakes/fascines depending on shading).

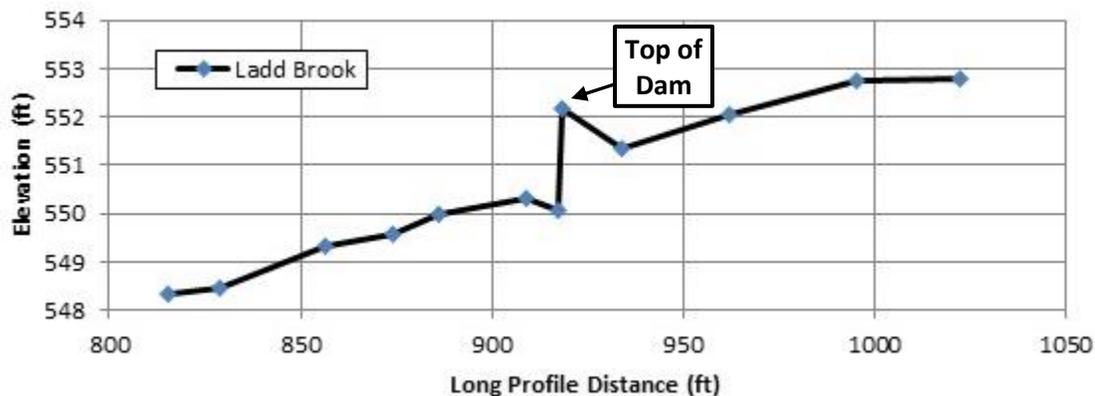
A makeshift dam constructed from railroad ties, stumps, and a rubber liner is found just upstream of the mobile home park (Figures 14 – 15). The structure is causing sediment aggradation upstream and raises the water level just upstream of the mobile home park. This may exacerbate flooding in the park.

**Figure 21.** Long profile of Ladd Brook channel upstream and downstream of the makeshift dam.

The small size of the dam suggests it can be removed by hand. We estimate it would take two (2) laborers and a truck one (1) day to remove the structure and haul away the wood and liners so they do not clog either of the culvert crossings downstream. At the time of the field survey, the channel upstream of the dam appeared to have been recently dredged, resulting in a limited amount of sediment accumulation behind the dam. Due to the similar slope of the channel upstream and downstream of the dam as shown in Figure 21, likely no regrading of the channel is needed and what sediment is accumulated immediately behind the dam can be allowed to fill the scour hole downstream of the dam and depression left after the dam removal. Estimated total cost: \$1,000 - \$2,000.
